**Flood Control Project Maintenance
Levee Inspections**

Fall 2010 Levee Maintenance Deficiency Summary Report

San Joaquin River Basin

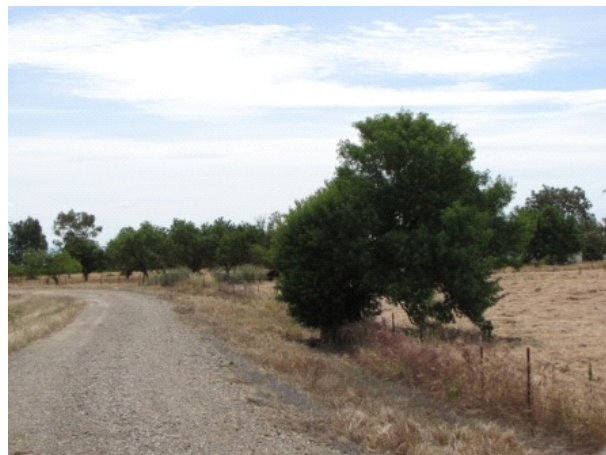
Levee Mile Report Line	7
Start Levee Mile	2.22
End Levee Mile	2.22
Location	Land Side
Category	Earthen Levee
Item	Trim / Thin Trees
View of a tree blocking visibility at the landward toe looking upstream.	
dpesaven_f_20100928_208.jpg

7	2.22	2.22	Earthen Levee	Trim / Thin Trees	LS	M	Trim trees to at least five feet above ground level.	38.117773 ° -121.149879 °	38.117773 ° -121.149879 °	23 Y
8	2.37	2.43	Earthen Levee	Encroachments	LS	PO	Landscaping	38.118957 ° -121.147865 °	38.119761 ° -121.147461 °	8 Y
9	2.95	2.95	Interior Drainage & Piping Systems	Flap Gates	WS	U	Inspector Comments: The flap gate is broken and not able to close.	38.125896 ° -121.144001 °	38.125896 ° -121.144001 °	15 Y
10	3.53	3.92	Earthen Levee	Encroachments	CR	U	Fences Inspector Comments: Farmer has moved fence to water shouder of access road in high ground area of the unit. The fence is blocking access and the gate is locked with farmer's lock. Unable to access, inspect or patrol this portion of the unit.	38.134740 ° -121.133335 °	38.134740 ° -121.133335 °	10 Y

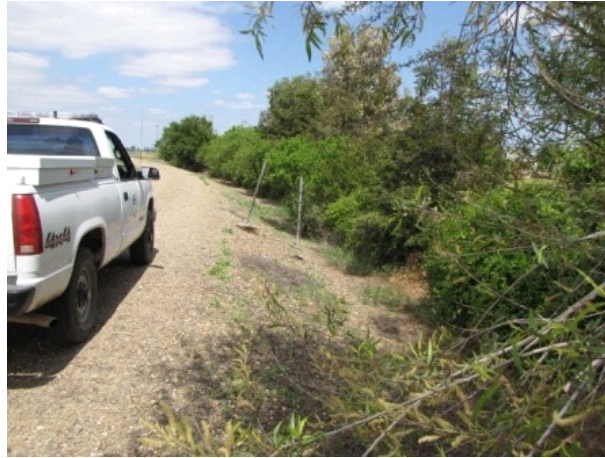
dpesaven_f_20100928_203.jpg

Landscaping on landward levee slope and within 10' of the toe.

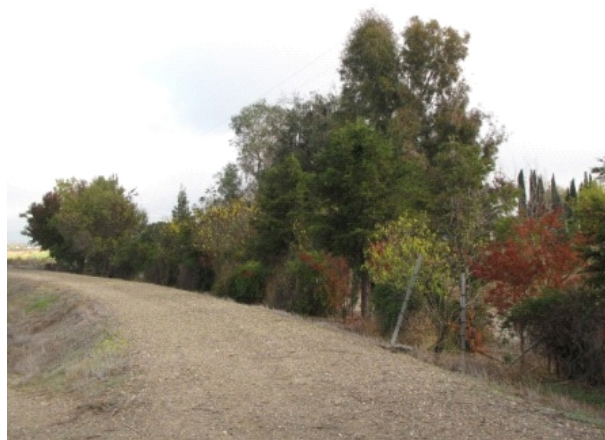
Levee Mile Report Line	8
Start Levee Mile	2.37
End Levee Mile	2.43
Location	Land Side
Category	Earthen Levee
Item	Encroachments

Updated view of landscaping as of fall 2009. The county has removed as much of the vegetation on the creek side of the fence as they can at this time.

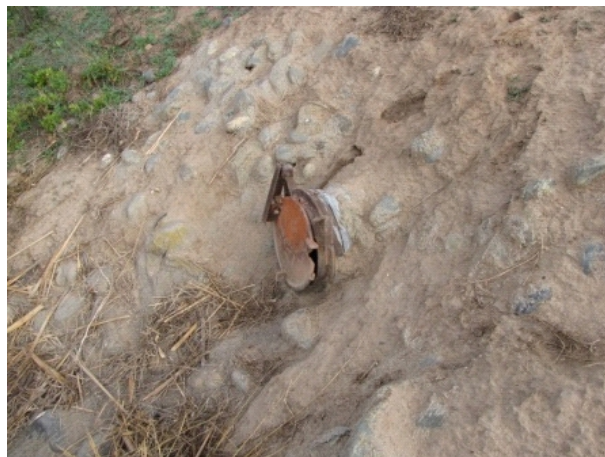
Levee Mile Report Line	9
Start Levee Mile	2.95
End Levee Mile	2.95
Location	Water Side
Category	Interior Drainage & Piping Systems
Item	Flap Gates

View of a flap gate that has been damaged and is unable to completely close.

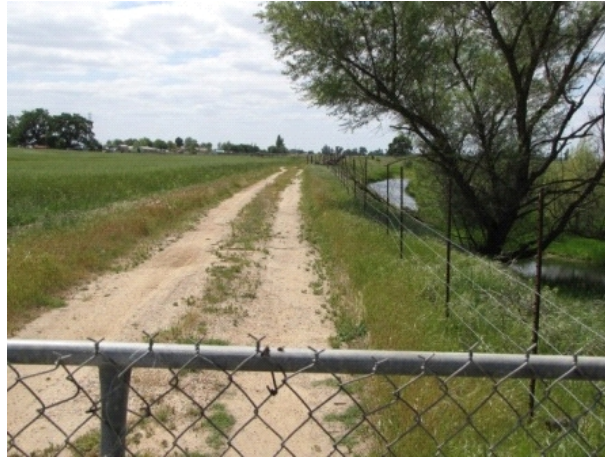
dpesaven_f_20100928_205.jpg

Fence along waterward sholder and crown of access road. The road cannot be driven through as the fence blocks access. The gate does not have a county key on the gate.

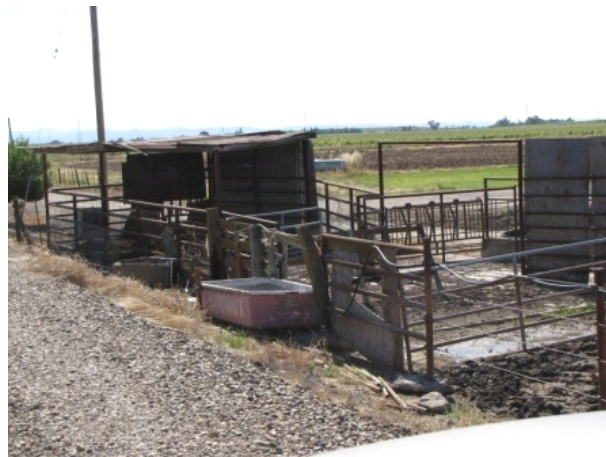
Levee Mile Report Line	3
Start Levee Mile	0.39
End Levee Mile	0.39
Location	Land Side
Category	Earthen Levee
Item	Encroachments

View of a tub/tank on the landward slope blocking access and visibility looking upstream.

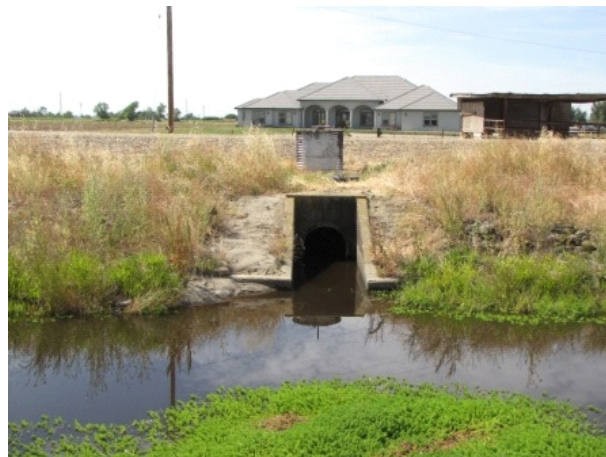
Levee Mile Report Line	4
Start Levee Mile	0.40
End Levee Mile	0.40
Location	Water Side
Category	Interior Drainage & Piping Systems
Item	Flap Gates

View of a outfall pipe with a missing flap gate looking from across the channel.

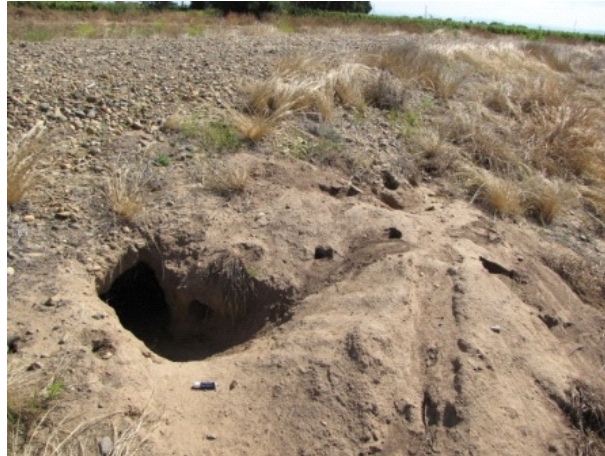
dpesaven_f_20100928_210.jpg

View of a large hole in the landward slope of the levee looking upstream.

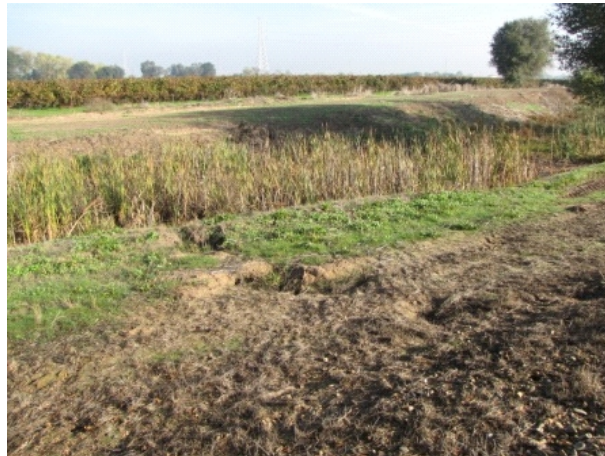
Levee Mile Report Line	14
Start Levee Mile	1.32
End Levee Mile	1.32
Location	Water Side
Category	Earthen Levee
Item	Erosion / Bank Caving

View of erosion on the waterward berm and in the waterward toe likely due to rodent activity looking upstream.

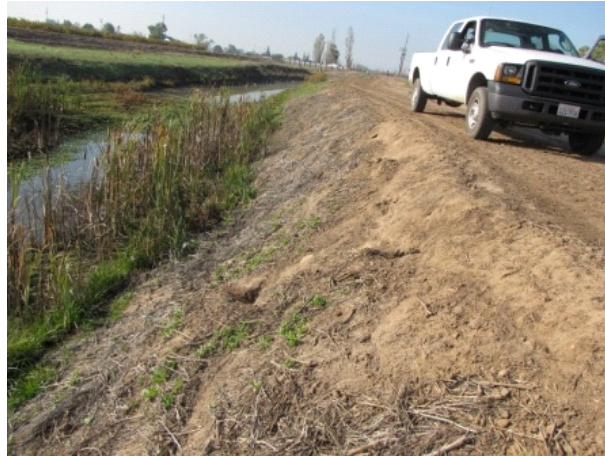
dpesaven_f_20101117_549.jpg

View of rodent holes in the waterward berm looking downstream.

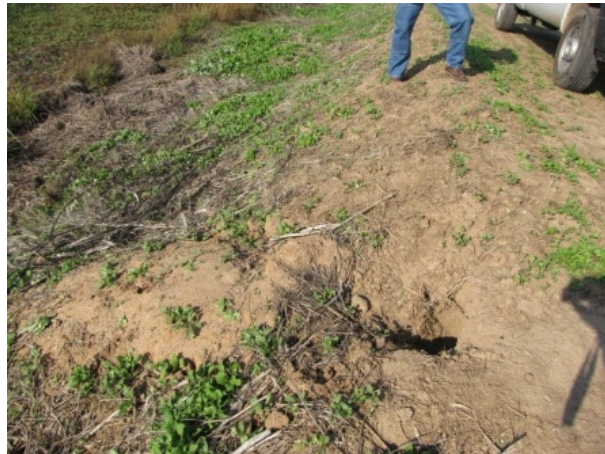
View of a large diameter rodent hole in the waterward berm looking downstream.

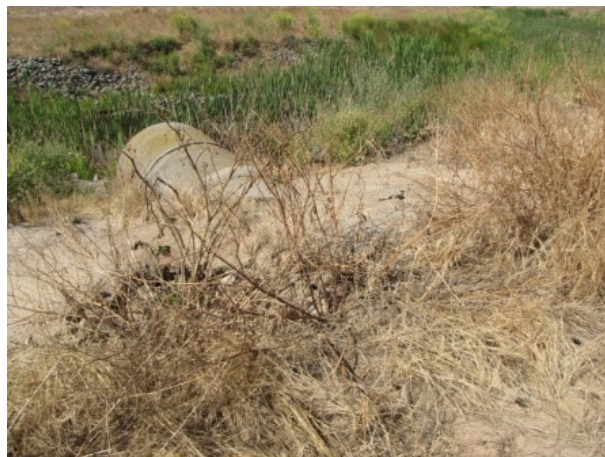
Levee Mile Report Line	3
Start Levee Mile	1.17
End Levee Mile	1.17
Location	Water Side
Category	Earthen Levee
Item	Erosion / Bank Caving

View of erosion and concrete apron settlement around the outfall pipe looking toward the channel and downstream.

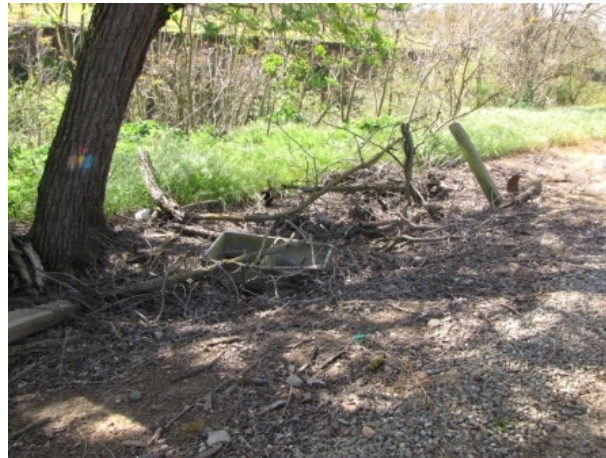
View of branches and debris on the waterward slope looking downstream.

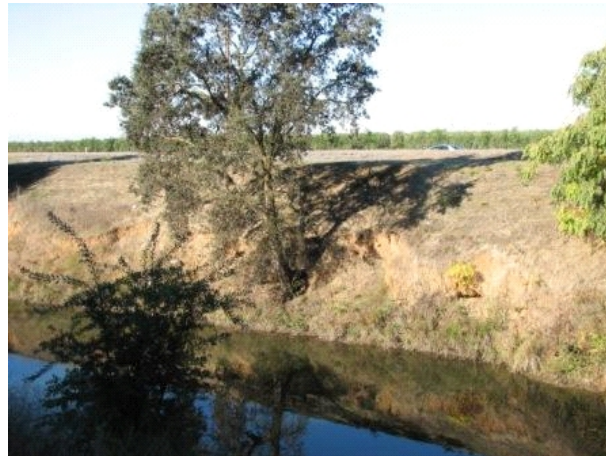
Levee Mile Report Line	3
Start Levee Mile	0.41
End Levee Mile	1.32
Location	Water Side
Category	Supplemental
Item	DWR Erosion Survey

Looking downstream from the left bank.

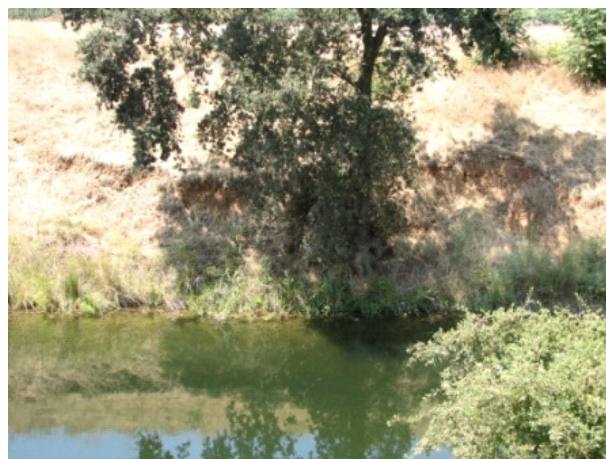
Levee Mile Report Line	3
Start Levee Mile	0.41
End Levee Mile	1.32
Location	Water Side
Category	Supplemental
Item	DWR Erosion Survey

Picture taken in 08/12/2009. Standing from the left bank and looking directly across at a section where tree stability may be affected by erosion.

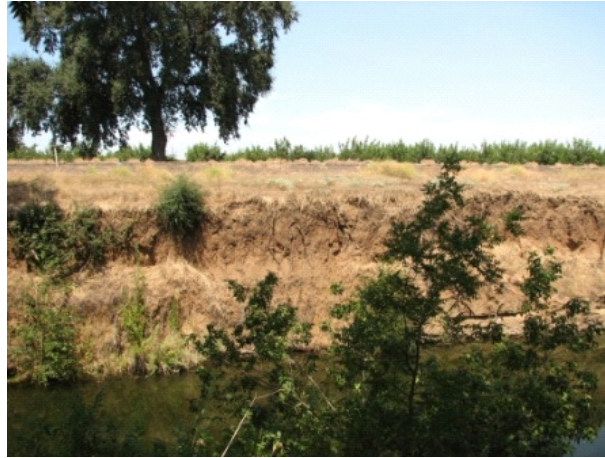
Looking upstream from the left bank. In some section of the 4800-ft long bank erosion, there is considerable amount of berm remaining.

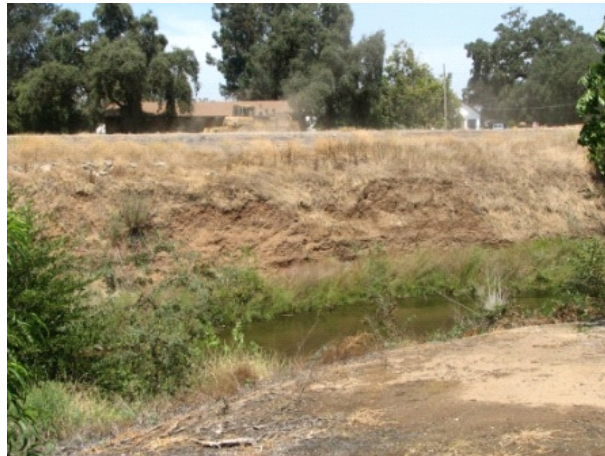
Levee Mile Report Line	3
Start Levee Mile	0.41
End Levee Mile	1.32
Location	Water Side
Category	Supplemental
Item	DWR Erosion Survey

Standing on the left bank and looking upstream.

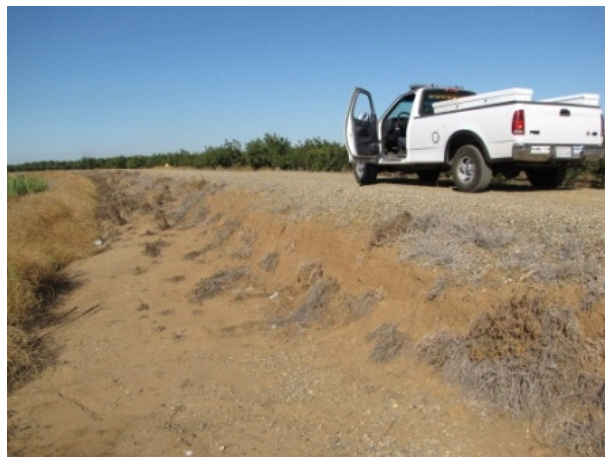
Levee Mile Report Line	4
Start Levee Mile	1.52
End Levee Mile	1.52
Location	Water Side
Category	Earthen Levee
Item	Erosion / Bank Caving

View of erosion of waterward levee slope looking upstream.

4	1.52	1.52	Earthen Levee	Erosion / Bank Caving	WS	M	Schedule repair of erosion site prior to the next inspection.	38.040202 ° -121.032659 °	38.040202 ° -121.032659 °	995 Y
5	1.55	1.62	Supplemental	DWR Erosion Survey	WS	U	Inspector Comments: 11/02/2010: No significant changes observed on site. Bank erosion extends approximately 100 feet downstream and 250 feet upstream of the drop structure. [2010 SiteID: NA0017U15RM1.58]	38.040170 ° -121.033800 °	38.040170 ° -121.033800 °	1 Y
6	2.08	2.08	Earthen Levee	Encroachments	WS		Pipe	38.036359 ° -121.041057 °	38.036359 ° -121.041057 °	2 Y
7	2.34	2.41	Earthen Levee	Vegetation	LS	M	Remove the wild growth other than native grasses from the levee slopes.	38.033604 ° -121.044243 °	38.033002 ° -121.045090 °	17 Y
8	2.36	2.36	Earthen Levee	Trim / Thin Trees	LS	C	Trim trees to at least five feet above ground level.	38.033497 ° -121.044351 °	38.033497 ° -121.044351 °	999 Y

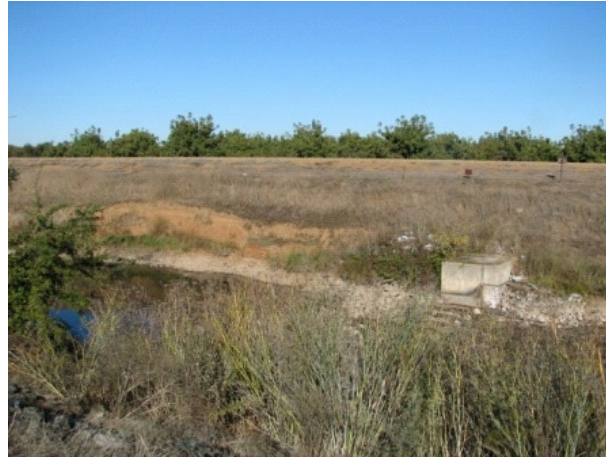
Looking at bank erosion downstream of the drop structure.

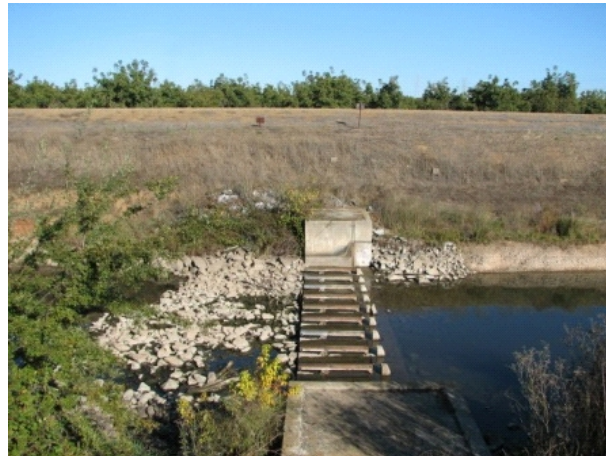
Levee Mile Report Line	5
Start Levee Mile	1.55
End Levee Mile	1.62
Location	Water Side
Category	Supplemental
Item	DWR Erosion Survey

Looking directly at the drop structure.

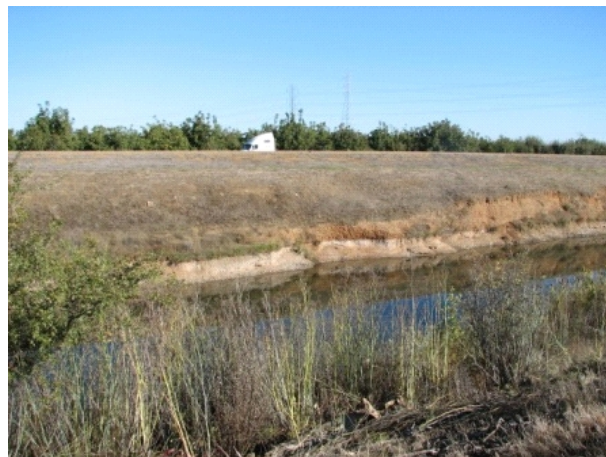
Levee Mile Report Line	5
Start Levee Mile	1.55
End Levee Mile	1.62
Location	Water Side
Category	Supplemental
Item	DWR Erosion Survey

Looking at bank erosion upstream of the drop structure.

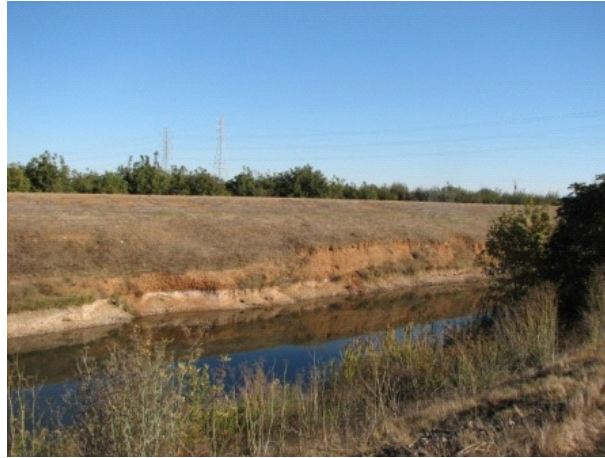
Looking at bank erosion upstream of the drop structure.

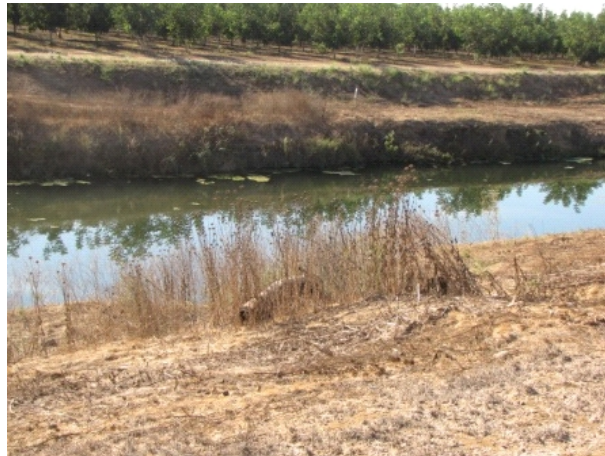
Levee Mile Report Line	6
Start Levee Mile	2.08
End Levee Mile	2.08
Location	Water Side
Category	Earthen Levee
Item	Encroachments

View of pipe on the surface of the waterward side of the levee looking downstream.

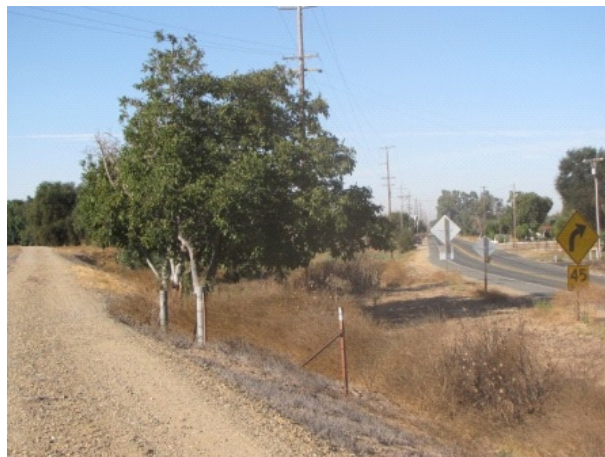
Levee Mile Report Line	7
Start Levee Mile	2.34
End Levee Mile	2.41
Location	Land Side
Category	Earthen Levee
Item	Vegetation

View of vegetation blocking visibility on the landward slope and toe of the levee looking downstream.

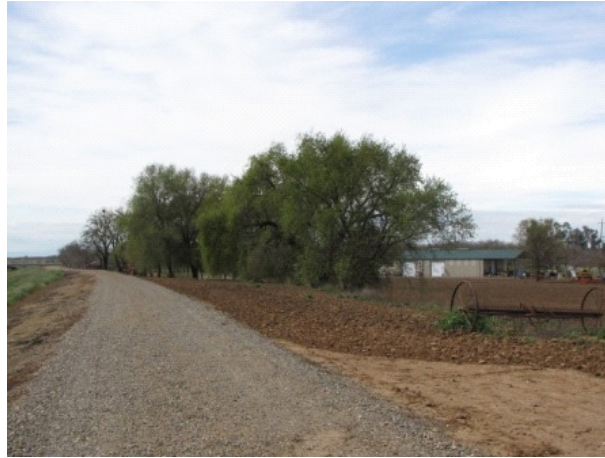
View of the landward shoulder where a landowner has disced the levee looking downstream.

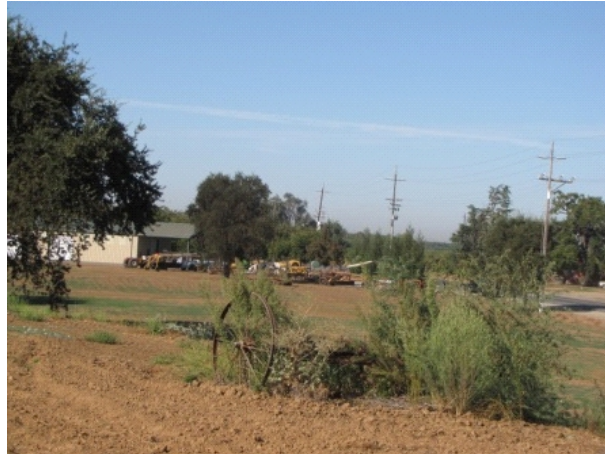
Levee Mile Report Line	10
Start Levee Mile	2.43
End Levee Mile	2.43
Location	Land Side
Category	Earthen Levee
Item	Encroachments

View of equipment on the landward slope of the levee looking downstream.

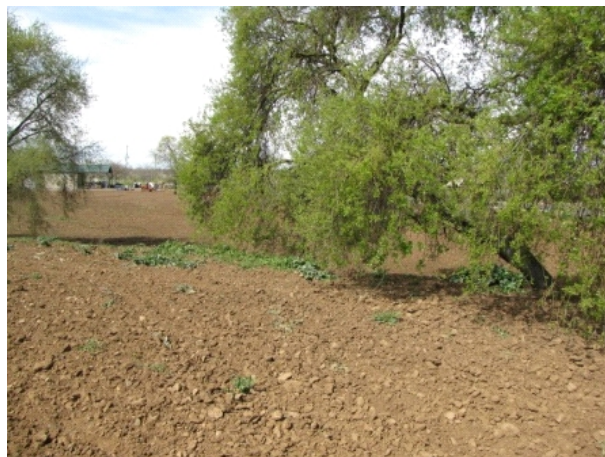
Levee Mile Report Line	11
Start Levee Mile	2.48
End Levee Mile	2.48
Location	Land Side
Category	Earthen Levee
Item	Trim / Thin Trees

View of a tree blocking visibility on the landward slope looking downstream.

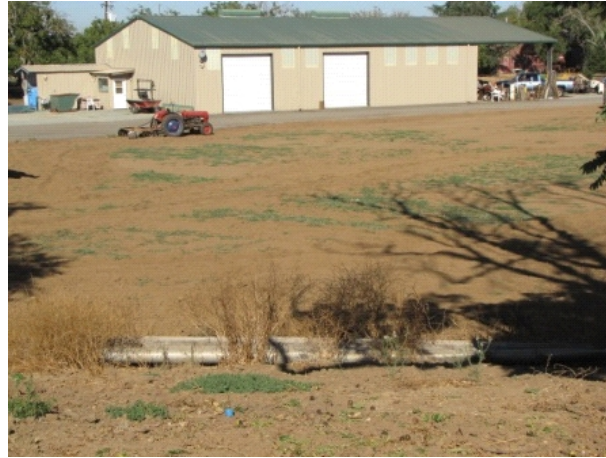
View of debris at the landward toe looking landward.

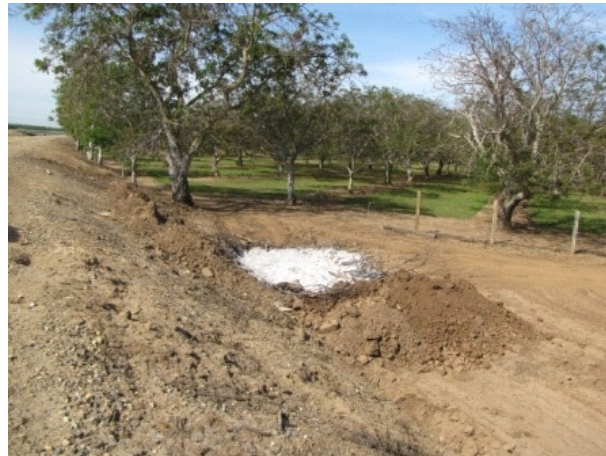
Levee Mile Report Line	14
Start Levee Mile	2.61
End Levee Mile	2.61
Location	Land Side
Category	Earthen Levee
Item	Slope Stability

Landowner has dug into the toe of the levee for the burn pile. Remove the debris and recompact the excavation at LM 2.61 on the landward side of the levee.

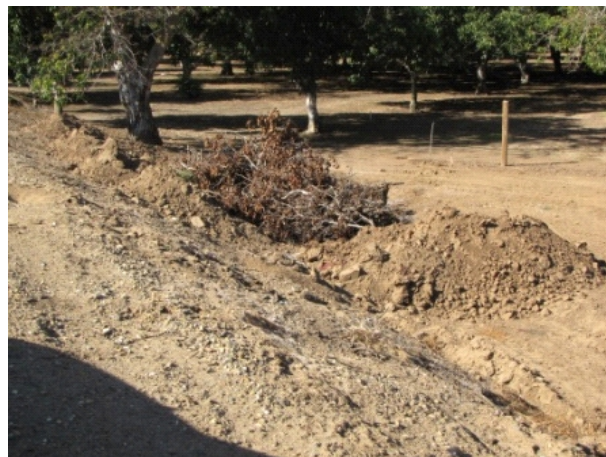
Levee Mile Report Line	14
Start Levee Mile	2.61
End Levee Mile	2.61
Location	Land Side
Category	Earthen Levee
Item	Slope Stability

View of farmer's excavation in the levee toe for a burn pile location looking upstream.

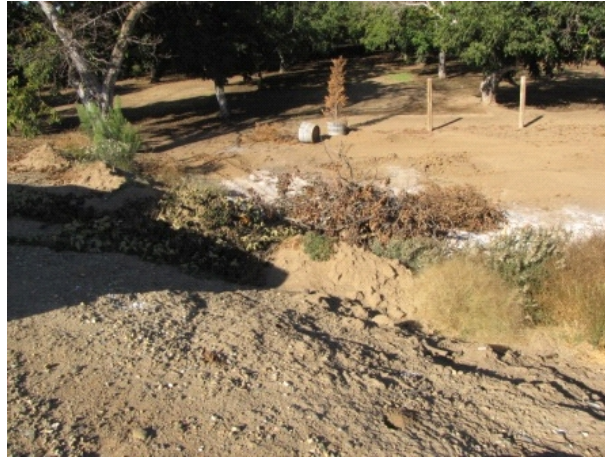
Fall 2010 updated view of the activity. Activity has decreased but not stopped.

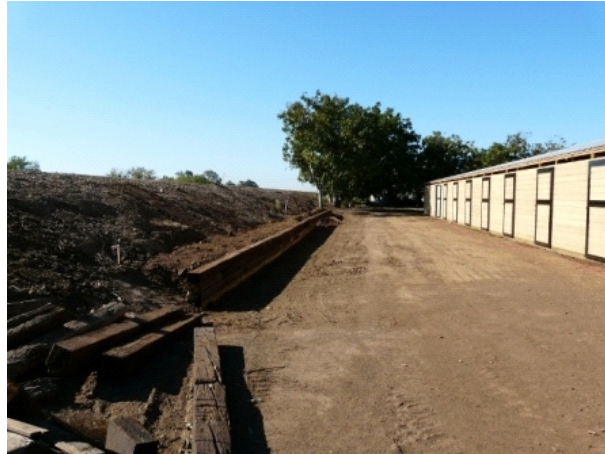
Levee Mile Report Line	15
Start Levee Mile	2.68
End Levee Mile	2.71
Location	Land Side
Category	Earthen Levee
Item	Encroachments

Recently built retaining wall at toe of landside levee at LM 2.68.

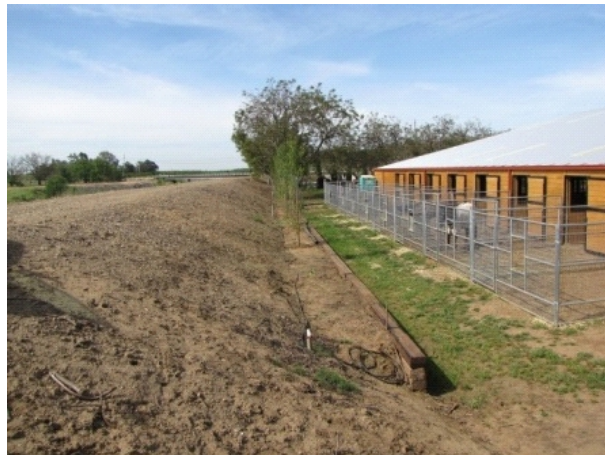
Levee Mile Report Line	15
Start Levee Mile	2.68
End Levee Mile	2.71
Location	Land Side
Category	Earthen Levee
Item	Encroachments

Updated view as of Spring 2009. Landscaping and irrigation has been added at the toe of the levee.

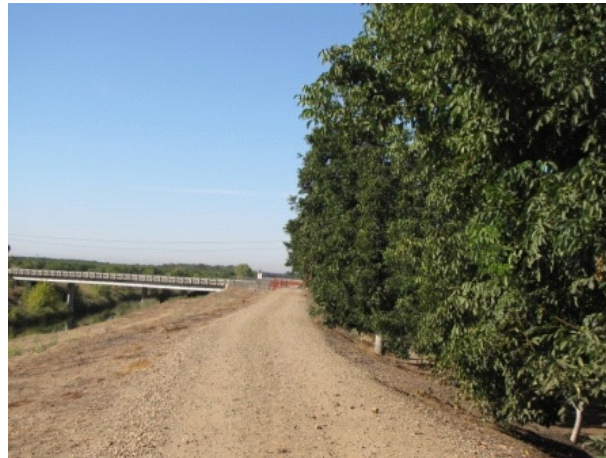
View of trees on the landward slope blocking visibility and access looking downstream.

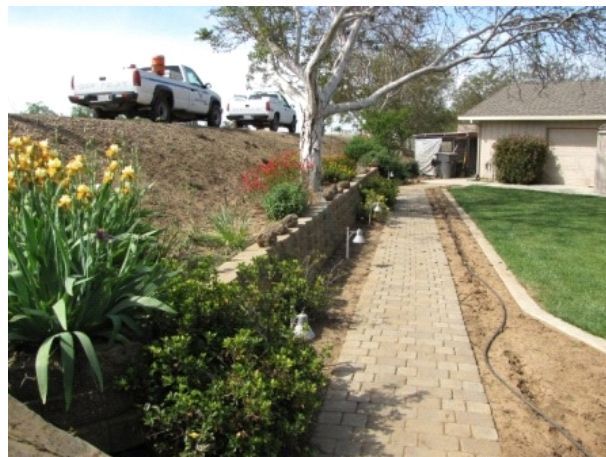
Levee Mile Report Line	18
Start Levee Mile	2.74
End Levee Mile	2.75
Location	Land Side
Category	Earthen Levee
Item	Encroachments

18	2.74	2.75	Earthen Levee	Encroachments	LS	PO	Buildings Inspector Comments: Retaining wall at landside toe of levee	38.029641 ° -121.049165 °	38.029505 ° -121.049372 °	959 Y
19	2.87	2.87	Earthen Levee	Encroachments	LS	M	Prunings Inspector Comments: Burn pile has been burned but new material has been placed.	38.028476 ° -121.050965 °	38.028476 ° -121.050965 °	4
20	2.93	2.93	Earthen Levee	Encroachments	LS	M	Pipe	38.027877 ° -121.051937 °	38.027877 ° -121.051937 °	51 Y
21	2.98	2.98	Earthen Levee	Encroachments	LS	M	Prunings Inspector Comments: Burn pile has been burned but new material has been placed.	38.027512 ° -121.052695 °	38.027512 ° -121.052695 °	5
22	3.04	3.04	Earthen Levee	Encroachments	LS	M	Prunings Inspector Comments: Burn pile has been burned but new material has been placed.	38.027173 ° -121.053526 °	38.027173 ° -121.053526 °	6
23	3.12	3.12	Earthen Levee	Encroachments	LS	M	Prunings Inspector Comments: Burn pile has been burned but new material has been placed.	38.026394 ° -121.054569 °	38.026394 ° -121.054569 °	7

View of retaining wall and landscaping along the landward toe of the levee.

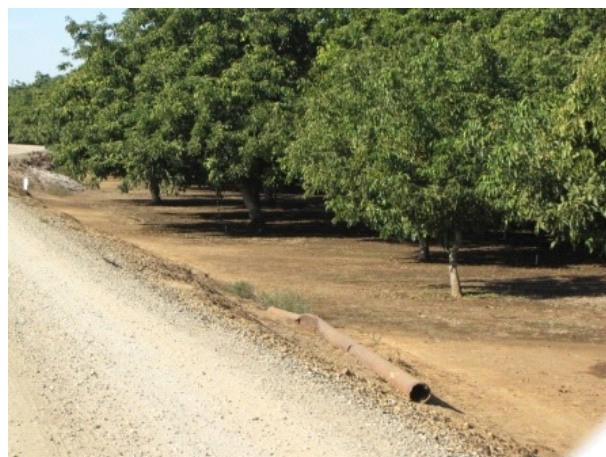
Levee Mile Report Line	20
Start Levee Mile	2.93
End Levee Mile	2.93
Location	Land Side
Category	Earthen Levee
Item	Encroachments

View of pipe on the surface of the landward toe looking downstream.

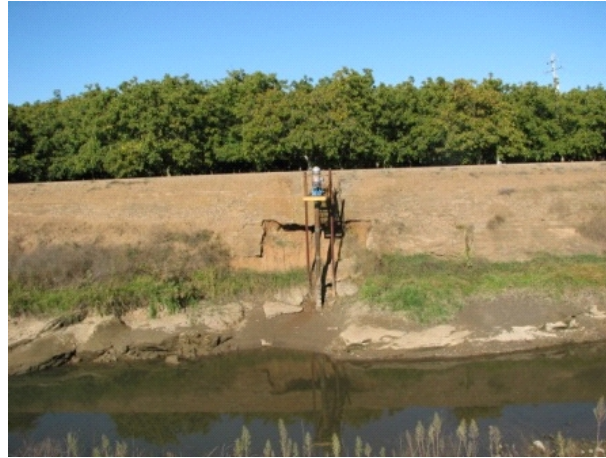
24	3.14	3.15	Supplemental	DWR Erosion Survey	WS	M	Inspector Comments: 11/02/2010: No significant changes observed on site. Upon further inspection, it appears that a slab of aging concrete lining on the bank slope has slipped, possibly due to a weekend subsoil layer. Fissure cracks have developed and now extend outward from where the initial slip occurred. Erosion of the subsoil layer could further weaken the bank and intrude into the levee prism. It could also affect the stability of the pump structure. [2010 SiteID: NA0017U15RM3.14]	38.026257 ° -121.054829 °	38.026257 ° -121.054829 °	14 Y
25	3.14	3.14	Earthen Levee	Erosion / Bank Caving	WS	U	Schedule repair of erosion site prior to the next inspection. Inspector Comments: Erosion under the concrete armoing has reached the level of the levee crown. Older evidence of rodent activity also noted in the area.	38.026112 ° -121.054835 °	38.026112 ° -121.054835 °	60 Y

Standing on the left bank looking directly at the erosion site.

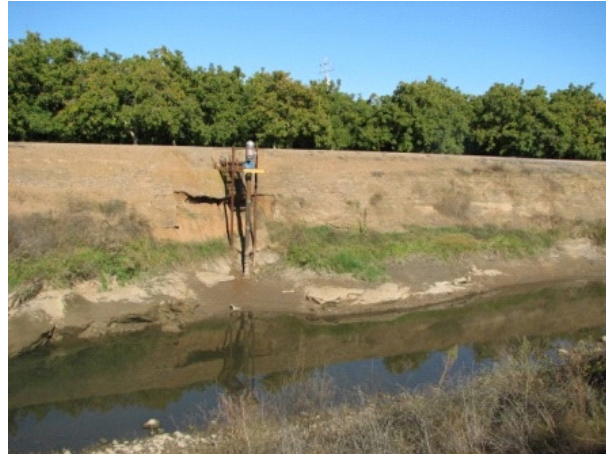
Levee Mile Report Line	24
Start Levee Mile	3.14
End Levee Mile	3.15
Location	Water Side
Category	Supplemental
Item	DWR Erosion Survey

Looking upstram of the erosion site.

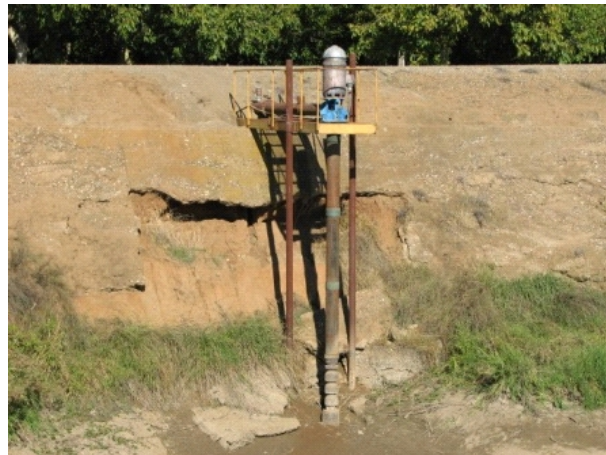
Levee Mile Report Line	24
Start Levee Mile	3.14
End Levee Mile	3.15
Location	Water Side
Category	Supplemental
Item	DWR Erosion Survey

Looking upsteam of the erosion site.

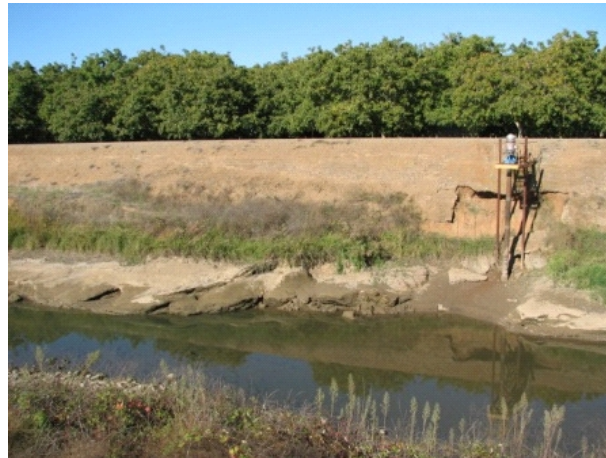
Looking downstream of the erosion site.

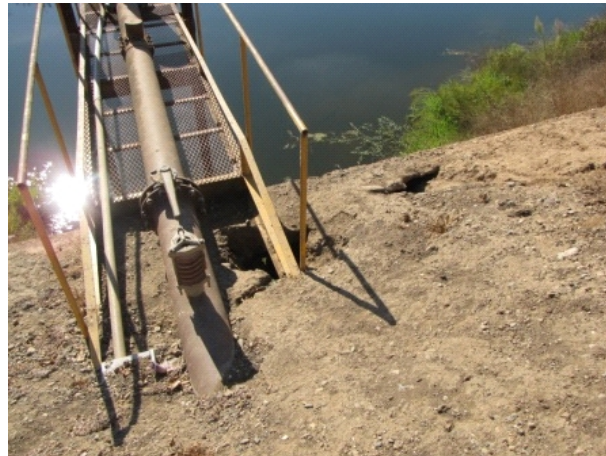
Levee Mile Report Line	25
Start Levee Mile	3.14
End Levee Mile	3.14
Location	Water Side
Category	Earthen Levee
Item	Erosion / Bank Caving

View of the cavity created behind concrete armoring at a pump looking waterward.

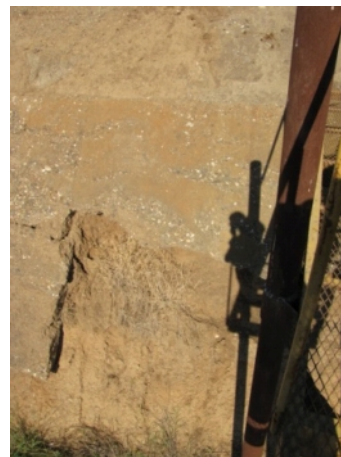
Levee Mile Report Line	25
Start Levee Mile	3.14
End Levee Mile	3.14
Location	Water Side
Category	Earthen Levee
Item	Erosion / Bank Caving

View of the cavity under the concrete armoring at the waterward toe. Note the missing concrete.

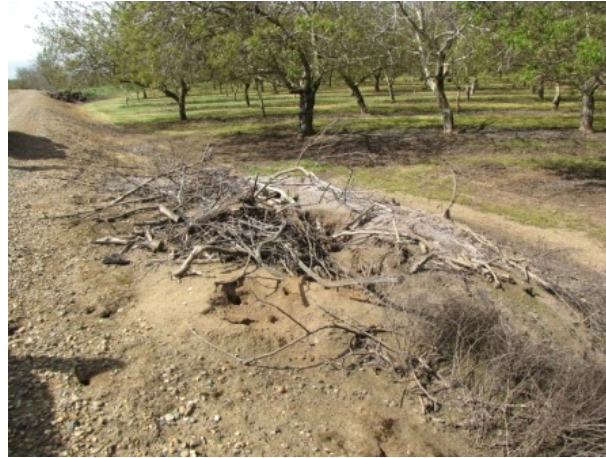
View of prunings on the landward slope looking downstream. Note the evidence of rodents.

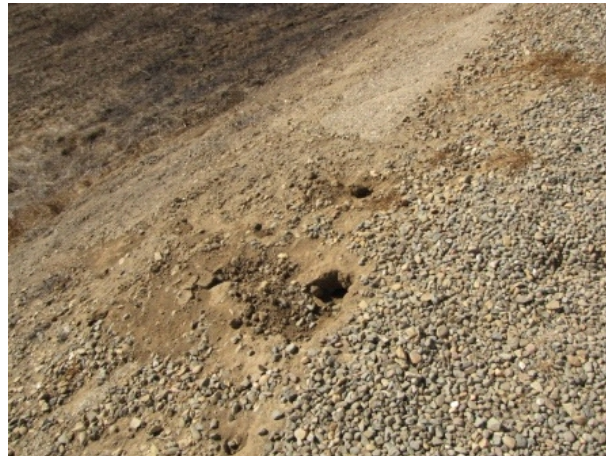
Levee Mile Report Line	32
Start Levee Mile	3.37
End Levee Mile	3.37
Location	Water Side
Category	Earthen Levee
Item	Animal Control

View of rodent holes in the waterward slope looking downstream.

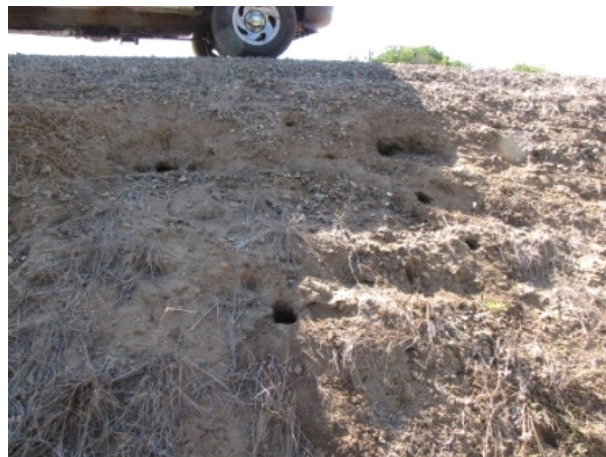
Levee Mile Report Line	34
Start Levee Mile	3.40
End Levee Mile	3.40
Location	Land Side
Category	Earthen Levee
Item	Animal Control

View of rodent holes on landward slope of levee.

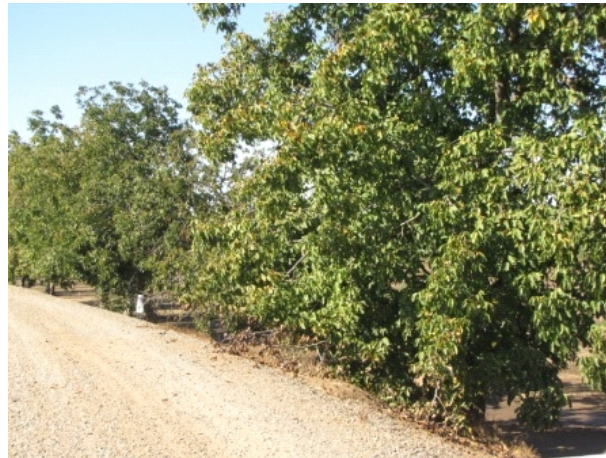
View of trees blocking visibility and access on the landward slope looking downstream.

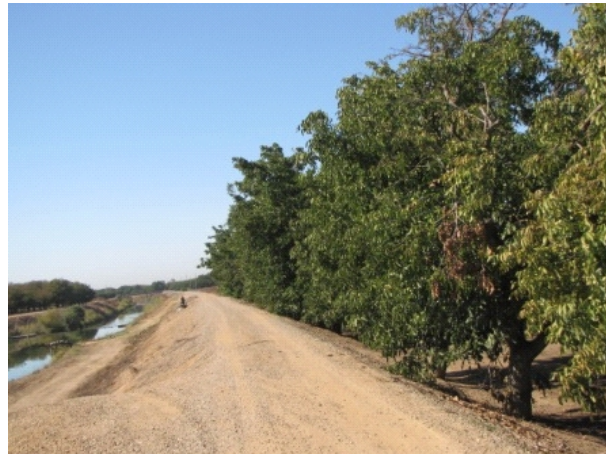
Levee Mile Report Line	39
Start Levee Mile	3.56
End Levee Mile	3.66
Location	Land Side
Category	Earthen Levee
Item	Trim / Thin Trees

View of trees on the landward slope blocking visibility and access looking downstream.

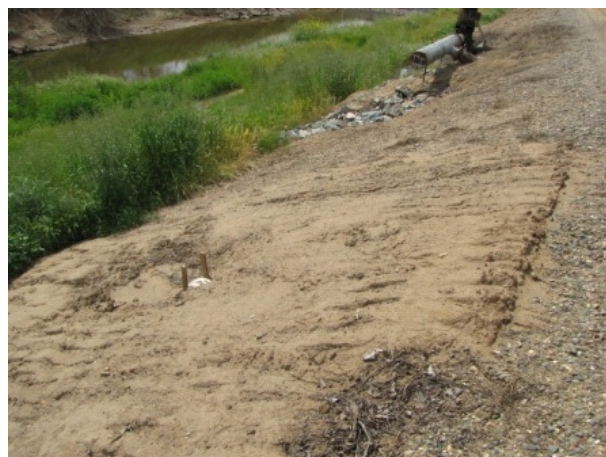
Levee Mile Report Line	42
Start Levee Mile	3.62
End Levee Mile	3.62
Location	Water Side
Category	Earthen Levee
Item	Encroachments

View of a recently place pipe in the waterward slope looking downstream.

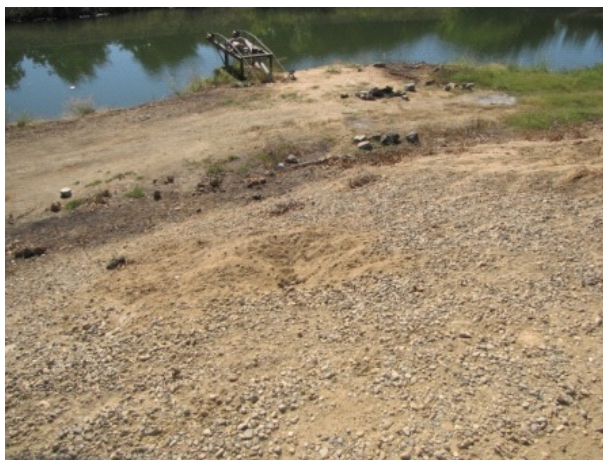
View of a rodent hole and tailings on the waterward slope looking waterward.

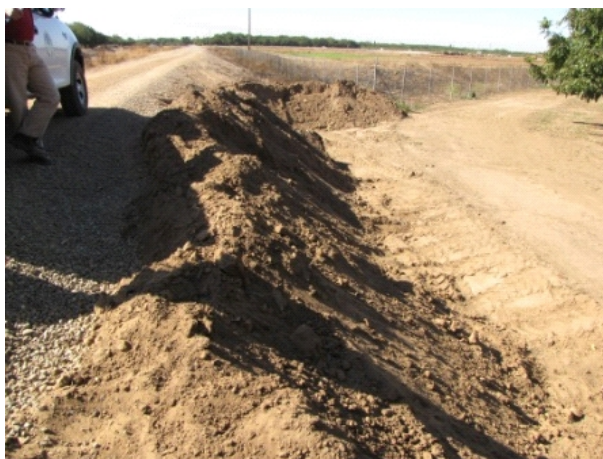
Levee Mile Report Line	44
Start Levee Mile	3.64
End Levee Mile	3.66
Location	Land Side
Category	Earthen Levee
Item	Slope Stability

View of excavations and embankments created by landowner along the landward slope looking downstream.

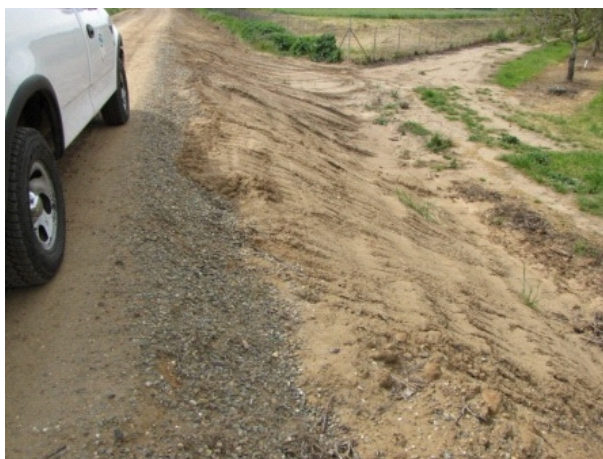
Updated view of the location with a partially completed repair looking downstream.

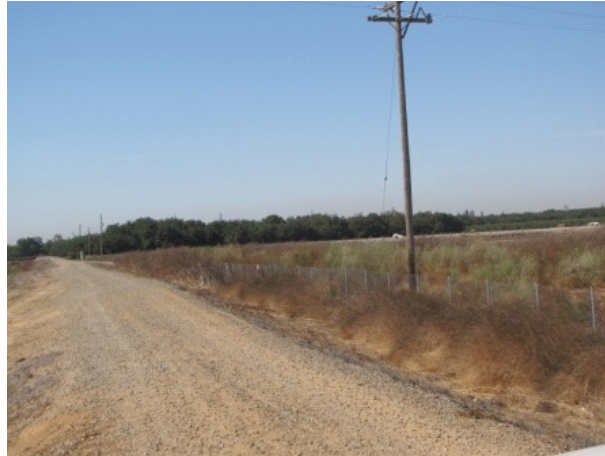
View of vegetation blocking visibility along the landward toe looking downstream.

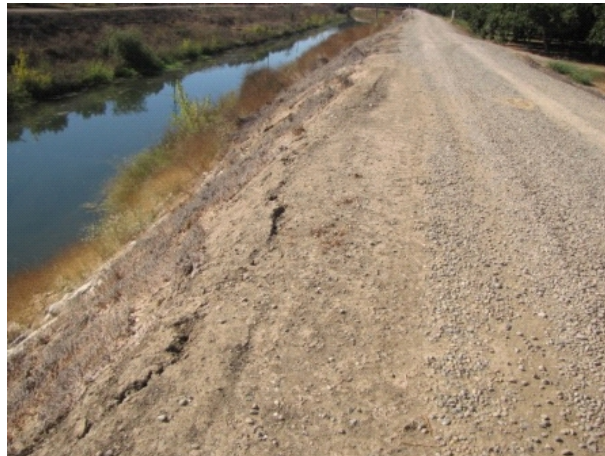
Levee Mile Report Line	46
Start Levee Mile	3.92
End Levee Mile	3.92
Location	Land Side
Category	Earthen Levee
Item	Cracking

View of cracking on the waterward shoulder occurring at an erosion repair looking downstream.

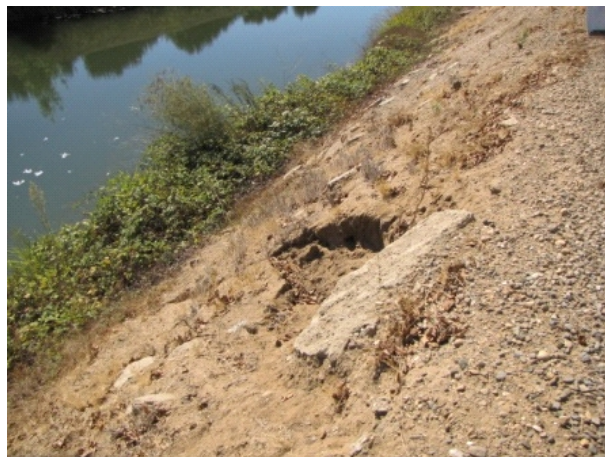
Levee Mile Report Line	51
Start Levee Mile	4.22
End Levee Mile	4.22
Location	Water Side
Category	Earthen Levee
Item	Animal Control

51	4.22	4.22	Earthen Levee	Animal Control	WS	U	Exterminate rodents and backfill and compact or grout burrows. Inspector Comments: Area has enlarged and is now a significant issue.	38.014965 ° -121.067482 °	38.014965 ° -121.067482 °	966 Y
52	4.29	4.29	Earthen Levee	Encroachments	LS	M	Prunings Inspector Comments: Burn pile has been burned but new material has been placed.	38.014025 ° -121.067983 °	38.014025 ° -121.067983 °	19 Y
53	4.38	4.64	Earthen Levee	Vegetation	LS	M	Remove the wild growth other than native grasses from the levee slopes.	38.012794 ° -121.068568 °	38.009268 ° -121.069677 °	77
54	4.73	4.73	Earthen Levee	Crown Surface / Depressions / Rutting	LS	C	Regrade the crown roadway for proper drainage. Inspector Comments: Recent pipe maintenance has not re-compacted levee properly.	38.007963 ° -121.070183 °	38.007963 ° -121.070183 °	968
55	4.83	4.83	Earthen Levee	Animal Control	LS	M	Exterminate rodents and backfill and compact or grout burrows.	38.006725 ° -121.070703 °	38.006725 ° -121.070703 °	80 Y

View of the rodent activity and resulting damage to the levee in the waterward slope looking downstream as of fall 2010.

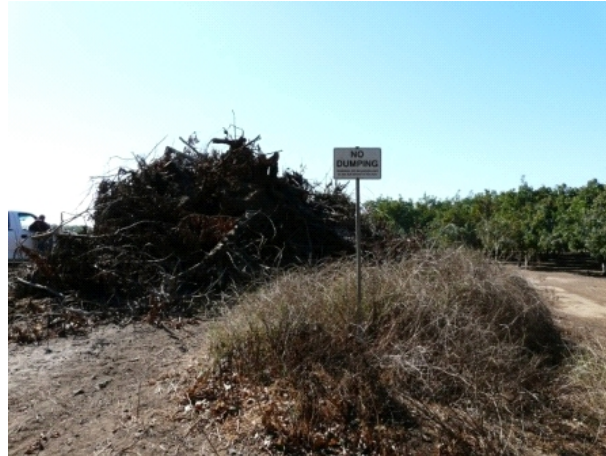
Example of a prunings pile immediately adjacent to access road at LM 4.29. Evidence of habitual burnings at this site.

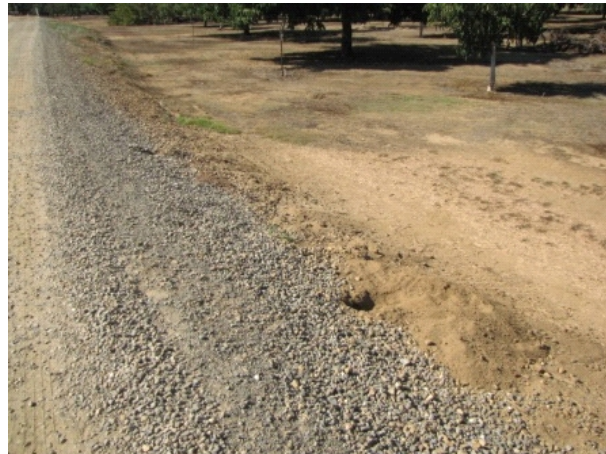
Levee Mile Report Line	55
Start Levee Mile	4.83
End Levee Mile	4.83
Location	Land Side
Category	Earthen Levee
Item	Animal Control

View of rodent activity in the landward slope and toe looking downstream.

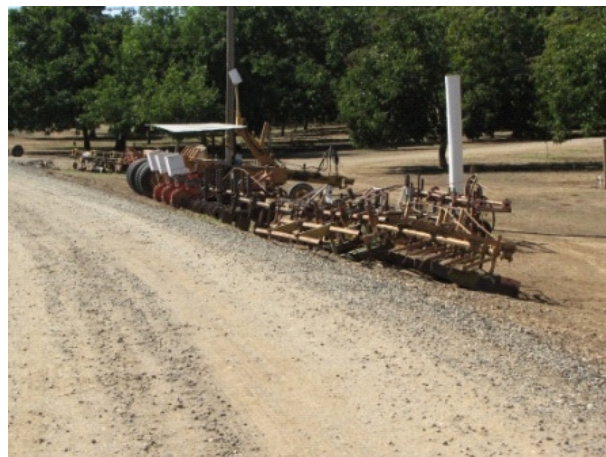
Levee Mile Report Line	57
Start Levee Mile	4.96
End Levee Mile	4.96
Location	Land Side
Category	Earthen Levee
Item	Encroachments

View of equipment along the landward slope looking downstream.

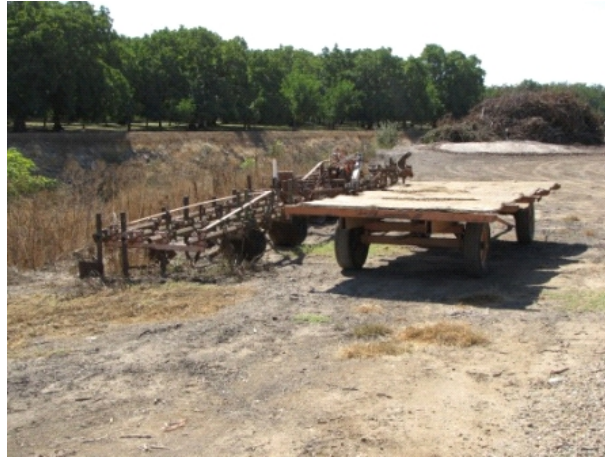
View of equipment along the waterward side of the levee crown looking downstream.

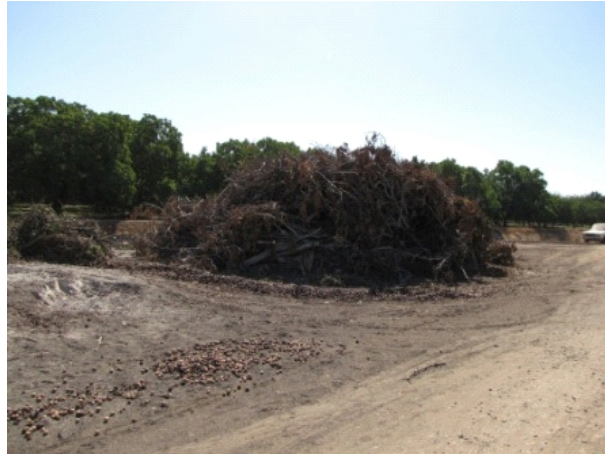
Levee Mile Report Line	59
Start Levee Mile	4.97
End Levee Mile	4.97
Location	Water Side
Category	Earthen Levee
Item	Encroachments

View of prunings pile along the waterward side of the crown looking downstream.

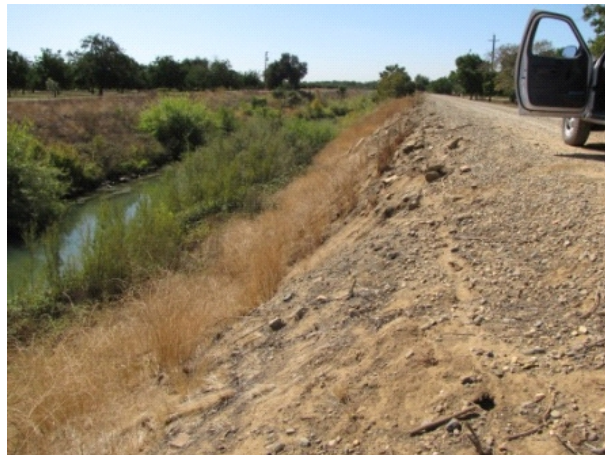
Levee Mile Report Line	61
Start Levee Mile	5.14
End Levee Mile	5.14
Location	Water Side
Category	Earthen Levee
Item	Slope Stability

View of a slip in the waterward levee slope looking downstream.

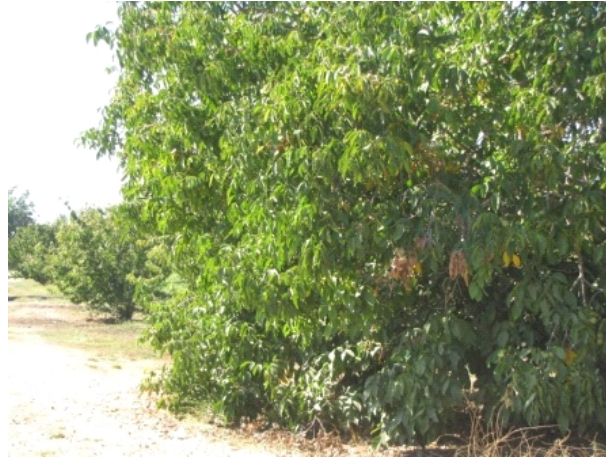
Levee Mile Report Line	63
Start Levee Mile	5.26
End Levee Mile	5.26
Location	Land Side
Category	Earthen Levee
Item	Trim / Thin Trees
View of trees on the landward slope blocking visibility and access looking downstream.	
dpesaven_f_20101003_436.jpg

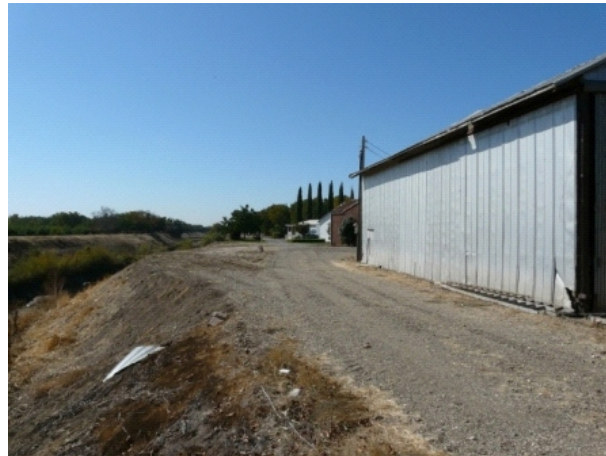
Levee Mile Report Line	66
Start Levee Mile	5.38
End Levee Mile	5.45
Location	Land Side
Category	Earthen Levee
Item	Encroachments
Building located immediately adjacent to access road approximately from LM 5.38 to 5.45	
dpesaven_f_20100928_230.JPG

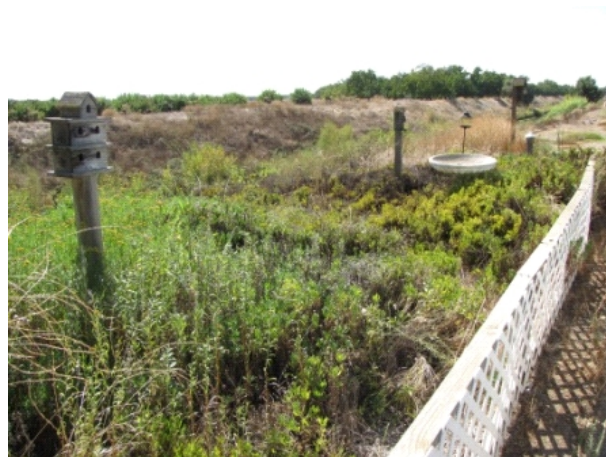
Levee Mile Report Line	67
Start Levee Mile	5.42
End Levee Mile	5.42
Location	Water Side
Category	Earthen Levee
Item	Encroachments
View of landscaping planted along the waterward side of the access road impacting visibility and the ability to floodfight looking downstream.	
dpesaven_f_20100928_280.jpg

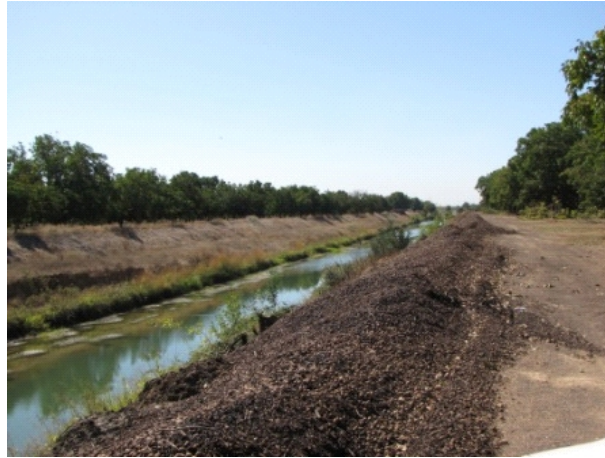
View of discarded nut shells placed along the waterward slope to be burned looking downstream.

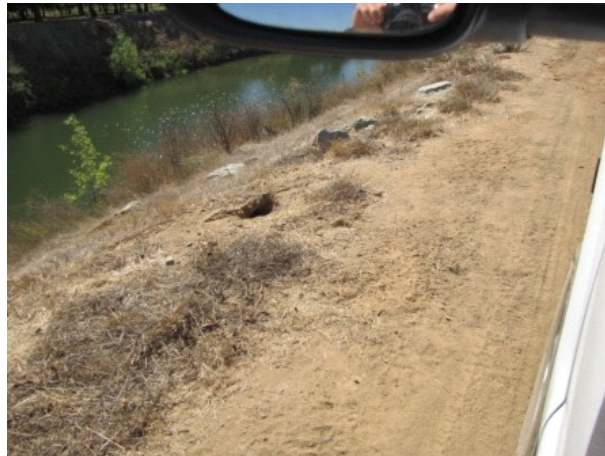
Levee Mile Report Line	71
Start Levee Mile	5.92
End Levee Mile	5.92
Location	Water Side
Category	Earthen Levee
Item	Animal Control

View of rodent activity in the waterward slope looking downstream.

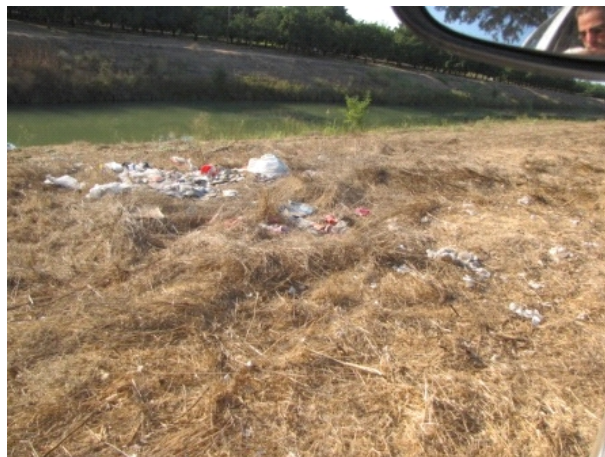
Levee Mile Report Line	73
Start Levee Mile	6.55
End Levee Mile	6.55
Location	Water Side
Category	Earthen Levee
Item	Encroachments

View of garbage on the waterward slope and berm looking downstream.
